**Flood Control Project Maintenance
Levee Inspections**

Fall 2013 Levee Maintenance Deficiency Summary Report

Sutter Maintenance Yard Maintenance Area 0012

Waterway	Bank	Unit Miles	Inspection Start/End	Inspector
Unit No. 01 Colusa Drain	Left	11.31	09/24/2013 09/24/2013	Bob Duffey

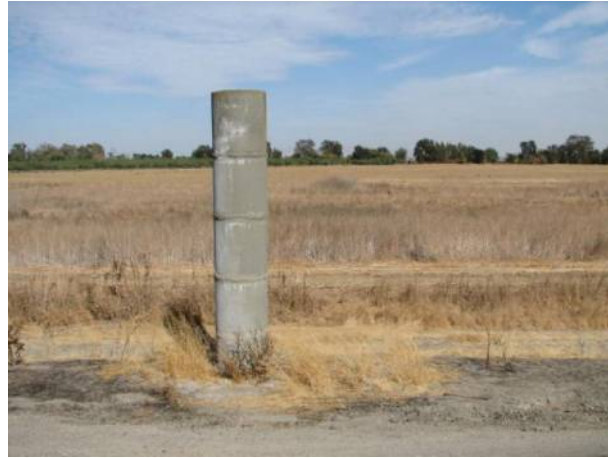
5	0.24	0.24	Supplemental	DWR UCIP Field Study	LS	M En	Inspector Comments: FS_ID:15910 EP_NO: 9381 Repair Type: Non-Urgent Crossing Status: Indicator Found UCIP Comments: Need to verify proper abandonment of pipe. 7/16/2013 Same as last inspection. FIELD_STRUCT_DESC: *Abandoned* 14-inch pipe through levee, 3.0 feet below crown. Open on waterward end. 3-foot x 6-foot concrete well on waterward berm. Siphon breaker in 24-inch pipe riser on landward shoulder. 36-inch concrete standpipe on landward berm. (Permit No. 9381 - Tribble). Originally included in O+M Manual (1959). Asbuilt available 50-4-3081. (The only item identified is the 36-inch standpipe on the LS toe). FS Date: 7/17/2013 7:54:05 AM	39.035889 ° -121.996882 °	39.035889 ° -121.996882 °	15 Y
---	------	------	--------------	----------------------	----	---------	---	------------------------------	------------------------------	---------

Levee Mile Report Line	5
Start Levee Mile	0.24
End Levee Mile	0.24
Location	Land Side
Category	Supplemental
Item	DWR UCIP Field Study
36-inch concrete riser on LS toe.	
UCIP_8891.jpg

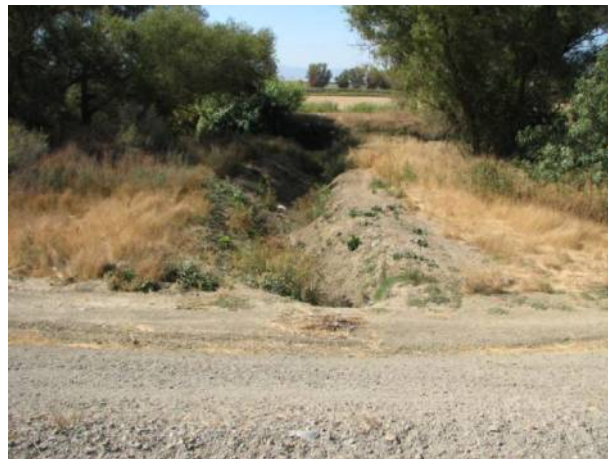
8	0.50	0.50	Supplemental	DWR UCIP Field Study	LS	M En	Inspector Comments: FS_ID:15912 EP_NO: 9382 Repair Type: Non-Urgent Crossing Status: Found UCIP Comments: Pipe is partially filled with soil. 7/16/2013 Sediment is built up against WS flapgate preventing it from opening. FIELD_STRUCT_DESC: 24-inch CM drain pipe through levee, 13.0 feet below the crown. Flap gate, concrete headwall and grouted cobble spillway on waterward side. Concrete headwall on landward side. (Permit No. 9382 Baber). Originally included in O+M manual (1959). Asbuilt available 50-4-3081. FS Date: 7/17/2013 8:03:14 AM	39.039413 ° -121.997766 °	39.039413 ° -121.997766 °	18 Y
---	------	------	--------------	-------------------------	----	---------	--	------------------------------	------------------------------	---------

Levee Mile Report Line	8
Start Levee Mile	0.50
End Levee Mile	0.50
Location	Land Side
Category	Supplemental
Item	DWR UCIP Field Study
Outlet at WS toe.	
UCIP_8893.jpg

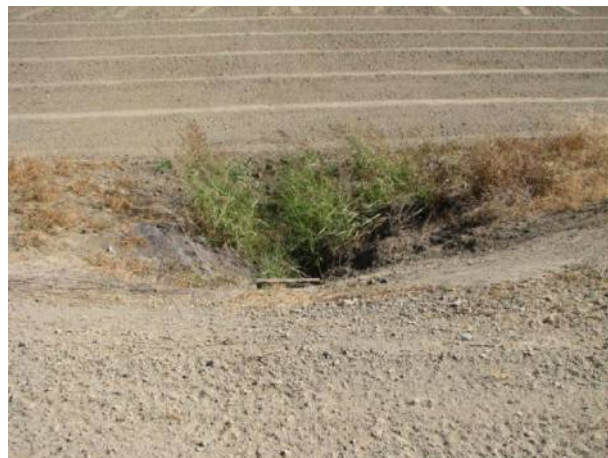
Levee Mile Report Line	10
Start Levee Mile	1.73
End Levee Mile	1.73
Location	Land Side
Category	Supplemental
Item	DWR UCIP Field Study
Inlet on LS toe.	
UCIP_8897.jpg

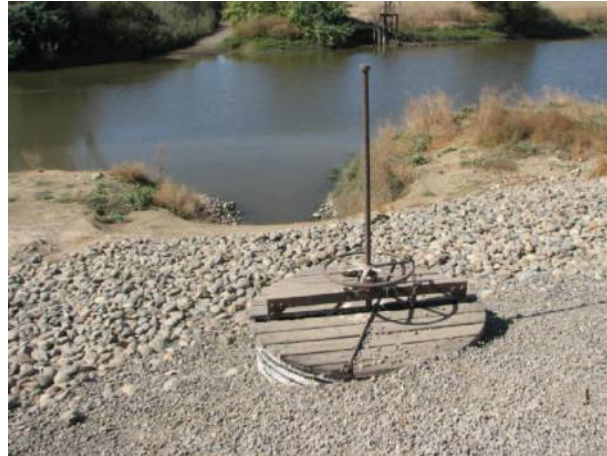
12	1.81	1.81	Supplemental	DWR UCIP Field Study	LS	M En	Inspector Comments: FS_ID:15919 EP_NO: 9387 Repair Type: Non-Urgent Crossing Status: Found UCIP Comments: No inlet could be located on LS. Flap gate partially blocked and will not close completely. 7/16/2013 Same as last inspection. Was told inlet is about 1/4 mile down road way next to house. Will try to get coordinates for inlet. FIELD_STRUCT_DESC: 48-inch drain pipe through the levee 20.0 feet below crown. Slide gate in 60-inch pipe riser on waterward slope. Flap gate and concrete headwall on waterward side. (Permit No. 9387 - Christenson). Originally included in O+M manual (1959). FS Date: 7/17/2013 8:17:53 AM	39.056847 ° -122.003288 °	39.056847 ° -122.003288 °	22 Y
----	------	------	--------------	-------------------------	----	---------	---	------------------------------	------------------------------	---------

Levee Mile Report Line	12
Start Levee Mile	1.81
End Levee Mile	1.81
Location	Land Side
Category	Supplemental
Item	DWR UCIP Field Study
60-inch standpipe with slide gate on WS slope with outlet in background.	
UCIP_8901.jpg

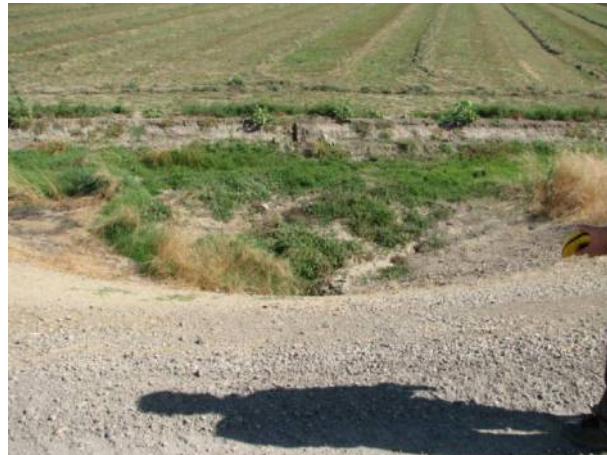
Levee Mile Report Line	16
Start Levee Mile	2.02
End Levee Mile	2.02
Location	Land Side
Category	Supplemental
Item	DWR UCIP Field Study
LS view of inlet.	
UCIP_8908.jpg

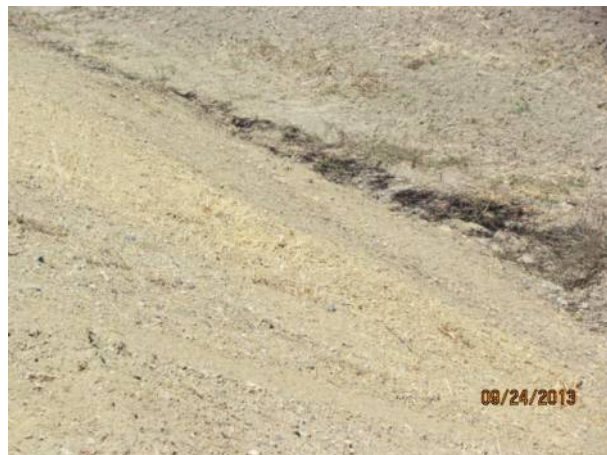
Levee Mile Report Line	18
Start Levee Mile	2.22
End Levee Mile	2.22
Location	Land Side
Category	Earthen Levee
Item	Animal Control
View of the rodent along the slope of the levee.	
rduffey_f_20131021_088.JPG

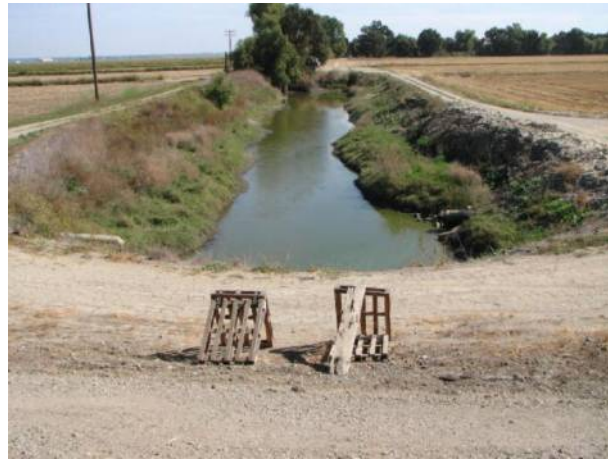
UCIP_8912.jpg

Drainage ditch on LS toe.

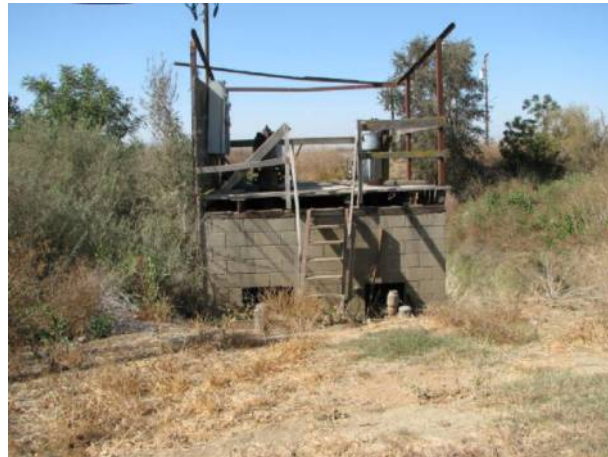
Levee Mile Report Line	22
Start Levee Mile	4.33
End Levee Mile	4.33
Location	Land Side
Category	Supplemental
Item	DWR UCIP Field Study

22	4.33	4.33	Supplemental	DWR UCIP Field Study	LS	M En	<p>Inspector Comments: FS_ID:15930 EP_NO: N/A Repair Type: Non-Urgent Crossing Status: Found UCIP Comments: No permit identified for this crossing.7/16/2013 Same as last inspection. FIELD_STRUCT_DESC: 24-inch steel pipe though levee, 4.5 feet below crown. Pump in pump house on waterward bank. Siphon breaker valve installed on LS shoulder. FS Date: 7/17/2013 8:29:45 AM</p>	39.089666 ° -122.015248 °	39.089666 ° -122.015248 °	30 Y
----	------	------	--------------	-------------------------	----	---------	--	------------------------------	------------------------------	---------

Pumping plant on WS toe.

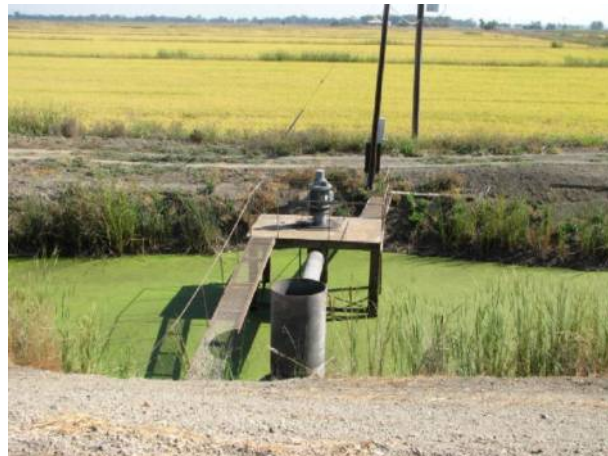
Levee Mile Report Line	26
Start Levee Mile	4.87
End Levee Mile	4.87
Location	Land Side
Category	Supplemental
Item	DWR UCIP Field Study

Pump, walkway, and standpipe on LS toe.

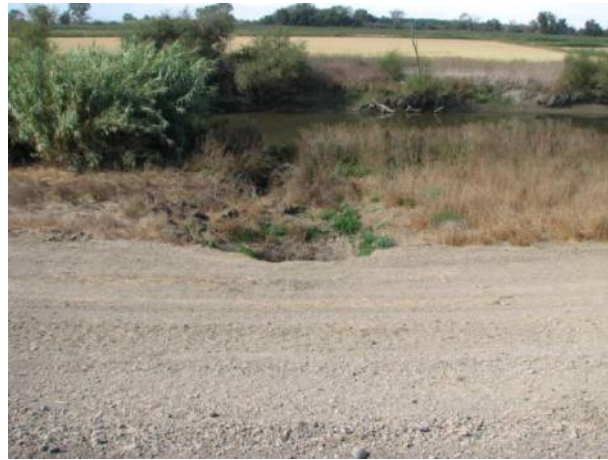
UCIP_3095.jpg

Outlet on WS toe.

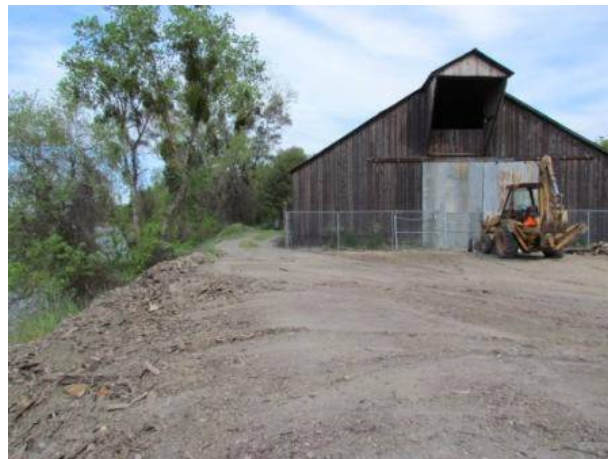
Levee Mile Report Line	31
Start Levee Mile	5.30
End Levee Mile	5.30
Location	Land Side
Category	Earthen Levee
Item	Animal Control

View of the levee slope with no rodent activity.

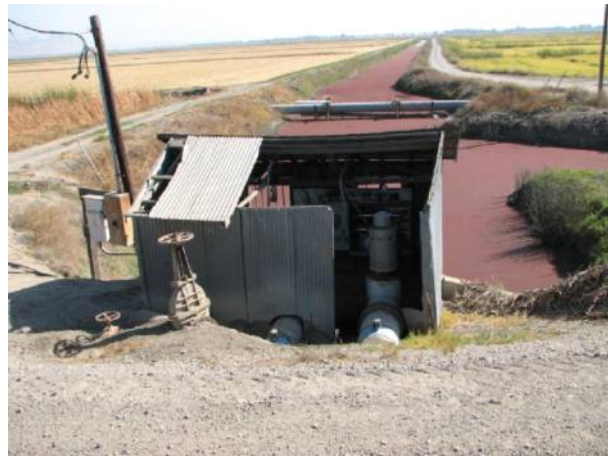
Levee Mile Report Line	35
Start Levee Mile	6.12
End Levee Mile	6.12
Location	Land Side
Category	Supplemental
Item	DWR UCIP Field Study

35	6.12	6.12	Supplemental	DWR UCIP Field Study	LS	M En	Inspector Comments: FS_ID:9002 EP_NO: 13699 Repair Type: Non-Urgent Crossing Status: Found UCIP Comments: Oil leakage around pump. FIELD_STRUCT_DESC: 1 of 2: 20-inch soilproofed steel Stormdrain pipe through levee, 4.4 feet below crown. Cobble revetted sump on waterward side. Siphon breaker in 24-inch metal pipe risers on waterward shoulder. Pump house at toe of landward slope. (Permit No. 13699, 1984). Replaced 18-inch pipe at same location. FS Date: 10/11/2012	39.114949 ° -122.017946 °	39.114949 ° -122.017946 °	38 Y
----	------	------	--------------	-------------------------	----	---------	---	------------------------------	------------------------------	---------

Pumping plant on LS slope

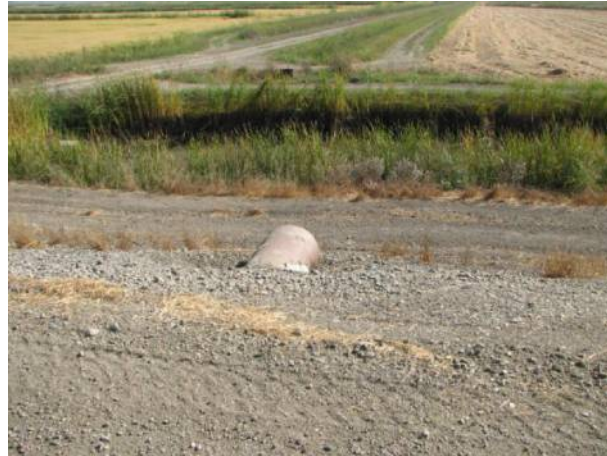
UCIP_8936.jpg

Pipe on LS.

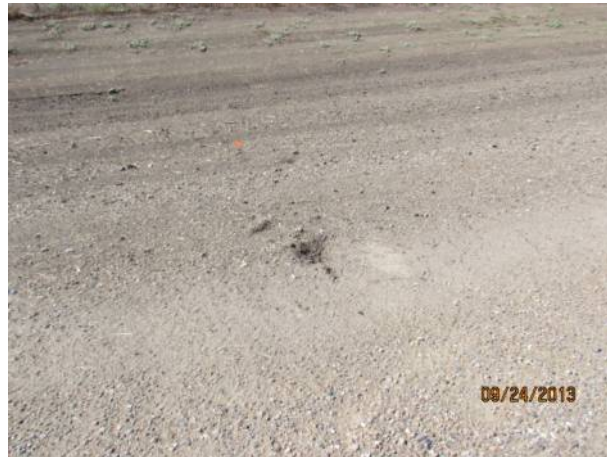
Levee Mile Report Line	46
Start Levee Mile	8.82
End Levee Mile	8.82
Location	Water Side
Category	Earthen Levee
Item	Animal Control

View of the rodent hole along the slope of the levee.

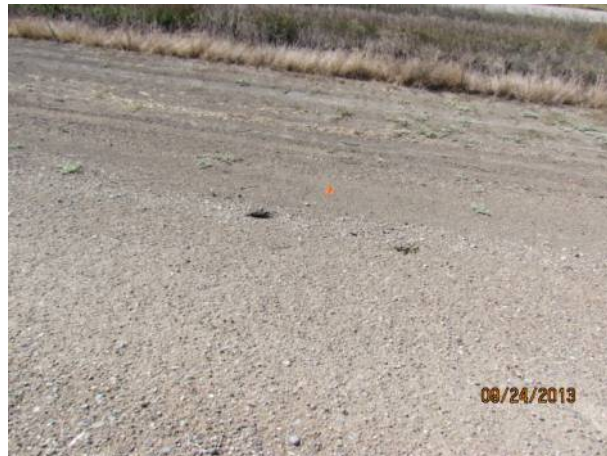
Levee Mile Report Line	47
Start Levee Mile	8.92
End Levee Mile	8.92
Location	Water Side
Category	Earthen Levee
Item	Animal Control

View of the rodent holes along the slope of the levee.

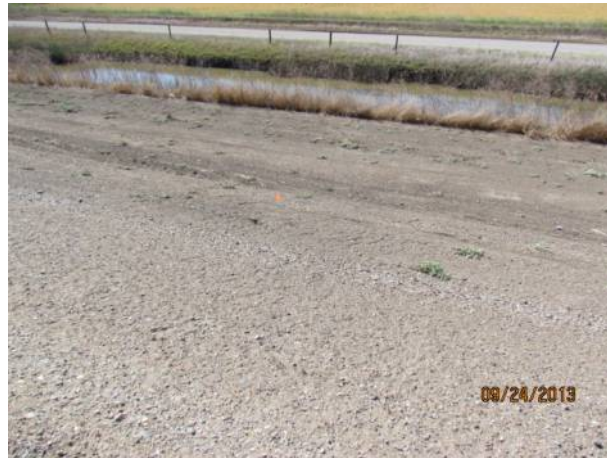
rduffey_f_20131021_091.JPG

View of the rodnet hole along the toe of the levee.

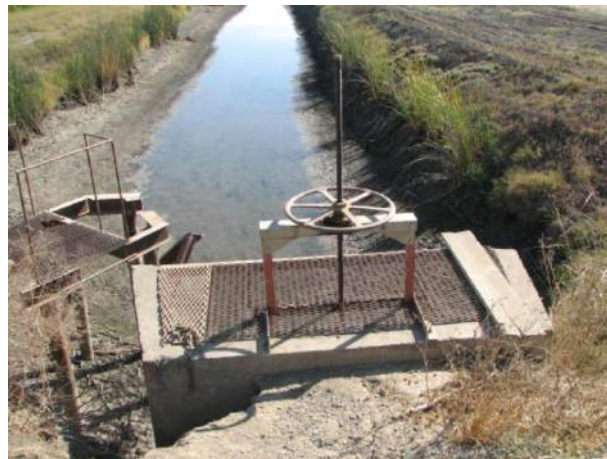
Levee Mile Report Line	51
Start Levee Mile	9.23
End Levee Mile	9.23
Location	Water Side
Category	Supplemental
Item	DWR UCIP Field Study

DWR ID: DWR_MA0012_01_f_2013_48										
51	9.23	9.23	Supplemental	DWR UCIP Field Study	WS	U En	Inspector Comments: FS_ID:6838 EP_NO: 9390 Repair Type: Urgent Crossing Status: Found UCIP Comments: Concrete Headwall tilting on WS slope. FIELD_STRUCT_DESC: 36-inch CM drain pipe through the levee, 15.0 feet below crown. Concrete head wall, slide gate and grouted revetment on waterward side. Slide gate and Concrete headwall on landward side. (Permit No. 9390 - Profpe). Originally included in O+M manual (1959). FS Date: 10/11/2012 1:29:25 PM	39.158097 ° -122.021706 °	39.158097 ° -122.021706 °	49 Y
DWR ID: DWR_MA0012_01_f_2013_49

slide gate and headwall on LS toe.

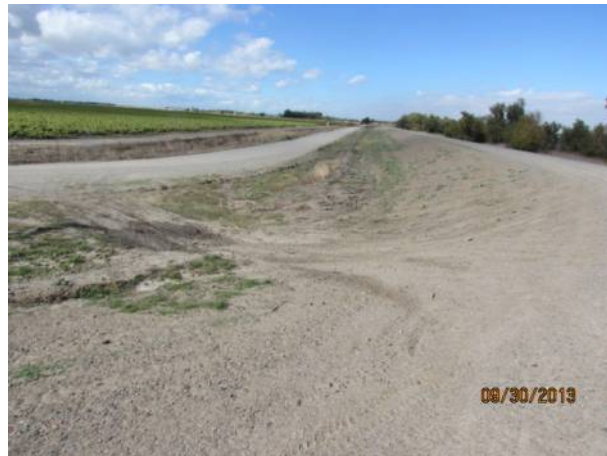
Levee Mile Report Line	53
Start Levee Mile	10.72
End Levee Mile	10.72
Location	Land Side
Category	Earthen Levee
Item	Slope Stability

View of the slope vehicle erosion.

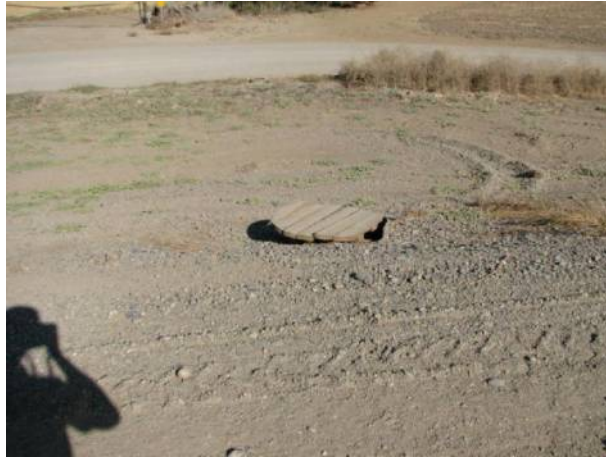
55	11.16	11.16	Supplemental DWR UCIP Field Study	LS	M En	Inspector Comments: FS_ID:15947 EP_NO: 9386 Repair Type: Non-Urgent Crossing Status: Found UCIP Comments: Pipe plugged with soil on both ends as well as at slide gate on WS slope. Slide gate inoperable.7/16/2013 Same as last inspection. FIELD_STRUCT_DESC: 24-inch Corrugated metal drainpipe through the levee, 8.0 feet below the crown. Slide gate in 36-inch pipe riser on the waterward shoulder. (Permit No. 9386 - Wescott) Levee turns eastward. FS Date: 7/17/2013 8:40:54 AM	39.180039 ° -122.014266 °	39.180039 ° -122.014266 °	51 Y
----	-------	-------	-----------------------------------	----	---------	---	------------------------------	------------------------------	---------

Levee Mile Report Line	55
Start Levee Mile	11.16
End Levee Mile	11.16
Location	Land Side
Category	Supplemental
Item	DWR UCIP Field Study
cover on 36-inch CMP standpipe on WS slope.	
UCIP_8944.jpg
